**Product Support Bulletin N° PSB002**  
31 July 1997

**Ventura HUD Monitor Blanking Problem and Solution**

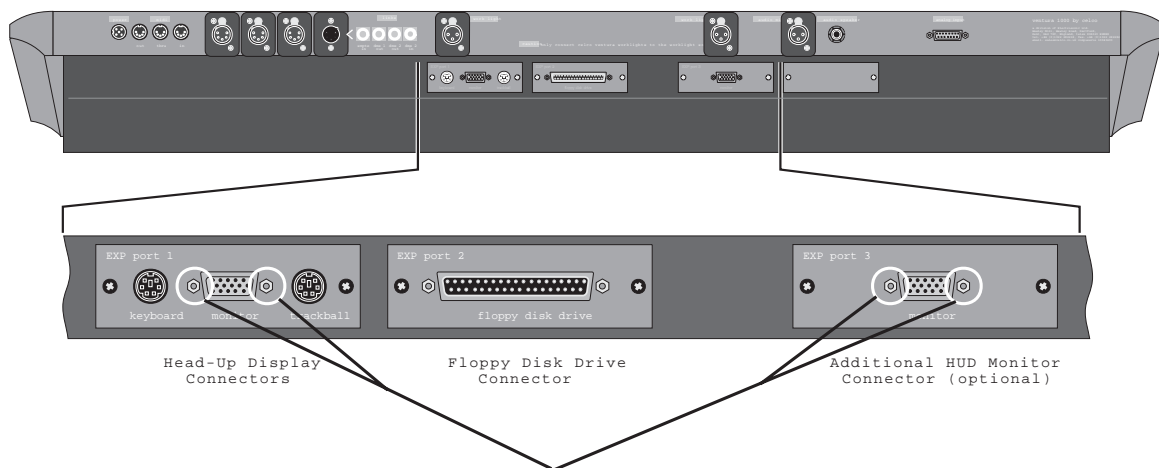
Investigation has revealed that this is being caused by a poor earth connection between the monitor connector and the mounting plate.

This is simply resolved by fitting shakeproof washers under the monitor cable retaining screws. The screws in question are marked on the attached drawing. The shakeproof washers should be fitted under each screw and to both connectors on a twin HUD version.

Fit shakeproof washers under these retaining screws
